TANK TYPE	MOUNT	LOCATION
Diaphragm	Pedestal	Apex

Part Number 80216-1

SIZE: 12.88-inch ID Sphere

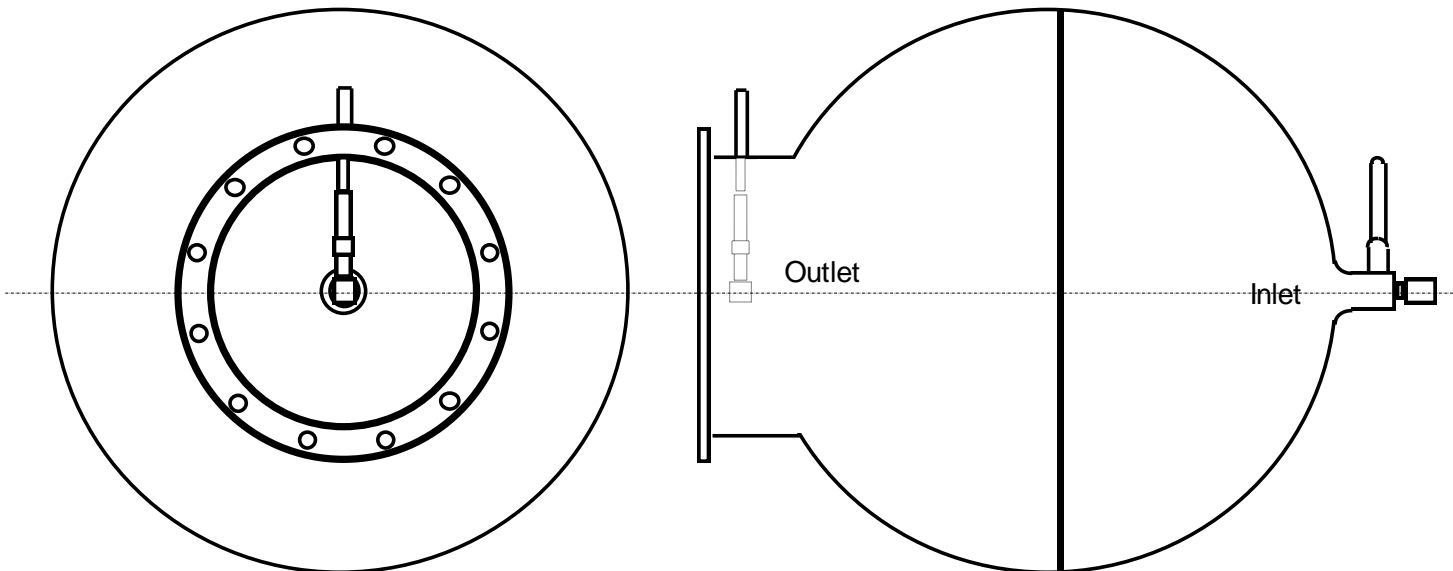
SKETCH NOT TO SCALE

This is a 13-inch spherical pressure vessel constructed of 6Al-4V titanium. Positive fuel expulsion is provided by a resersible ethylene propylene terpolymer (AF-E-332) rubber diaphragm retained (welded in) at the sphere mid-plane. Mounting is accomplished on a pedestal mount located on the apex of the propellant hemisphere.
